## BEACH BEHAVIOUR IN RESPONSE TO CHANGES IN WIND, WAVE, AND TIDAL CHARACTERISTICS AT BYRON BAY, NEW SOUTH WALES

Integrated Coastal Project for the  
Bachelor of Applied Science (Coastal Management)

University of New England - Northern Rivers  
Lismore, N.S.W.

June 1991

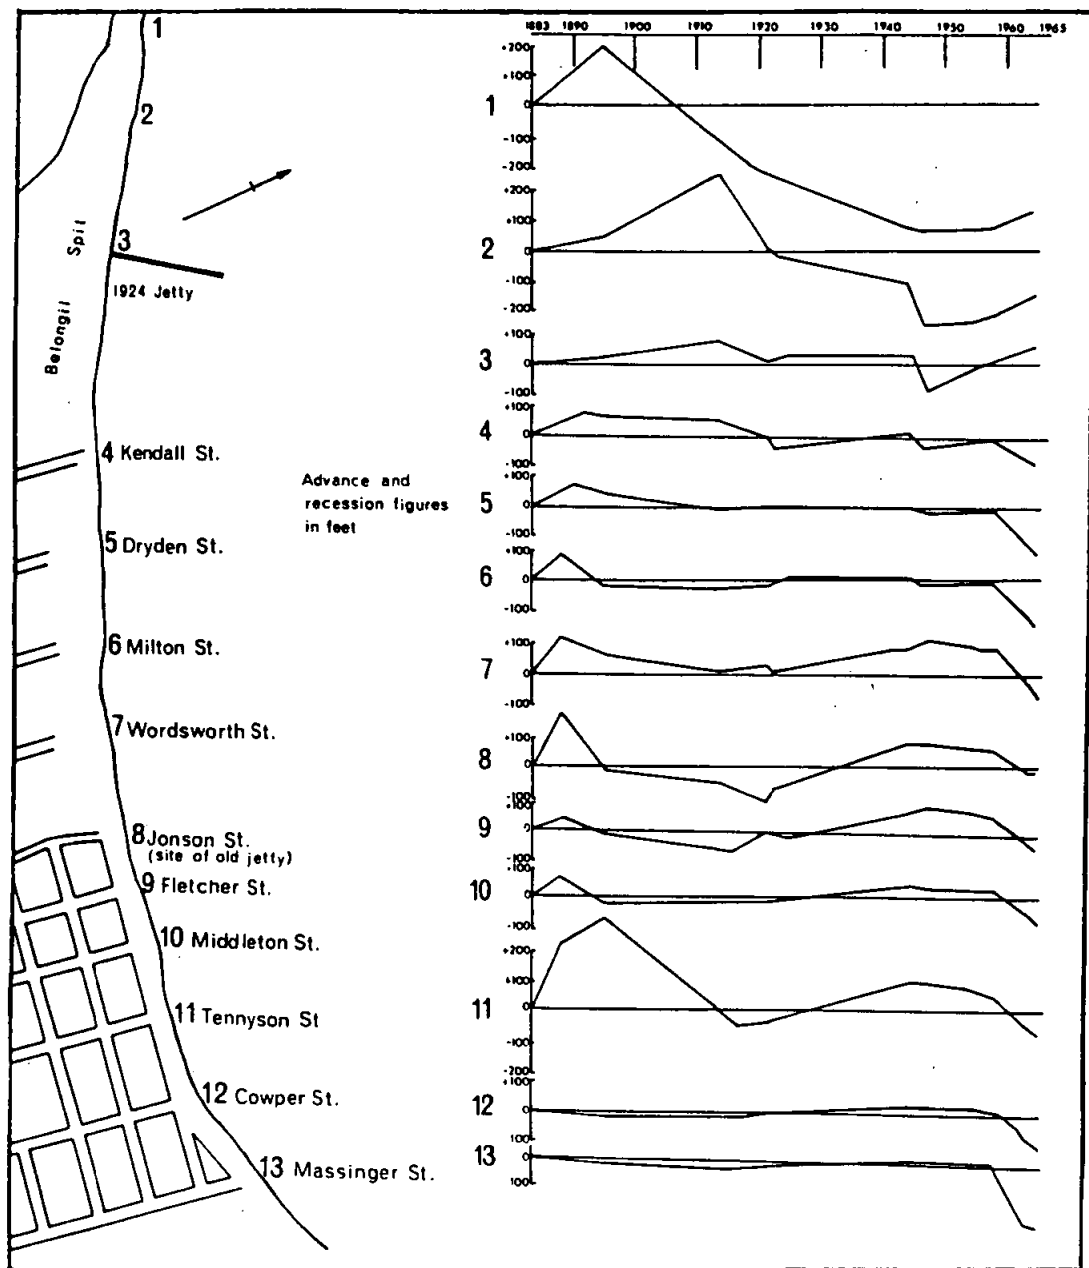
Figure 2: Aggradation and recession of the beachfront at Byron Bay, 1883 - 1965.

A study carried out by Hopley (1967) in Byron Bay used the intersection of extended street lines and the foot of the leading dune as observation points to gauge the amount of erosion or sand build-up (Fig. 2). At the eastern end of the beach only moderate movements of sand occurred between 1883 and 1958. The shoreline receded 7.6 metres in front of Massinger Street and 6.1 metres in front of Cowper Street between 1883 and 1915, but it was rebuilt by steady aggradation up to the mid-1940's. Rapid erosion occurred between 1959 and 1965 which caused the beach to retreat 61 metres in front of Massinger Street and 36.6 metres in front of Cowper Street.

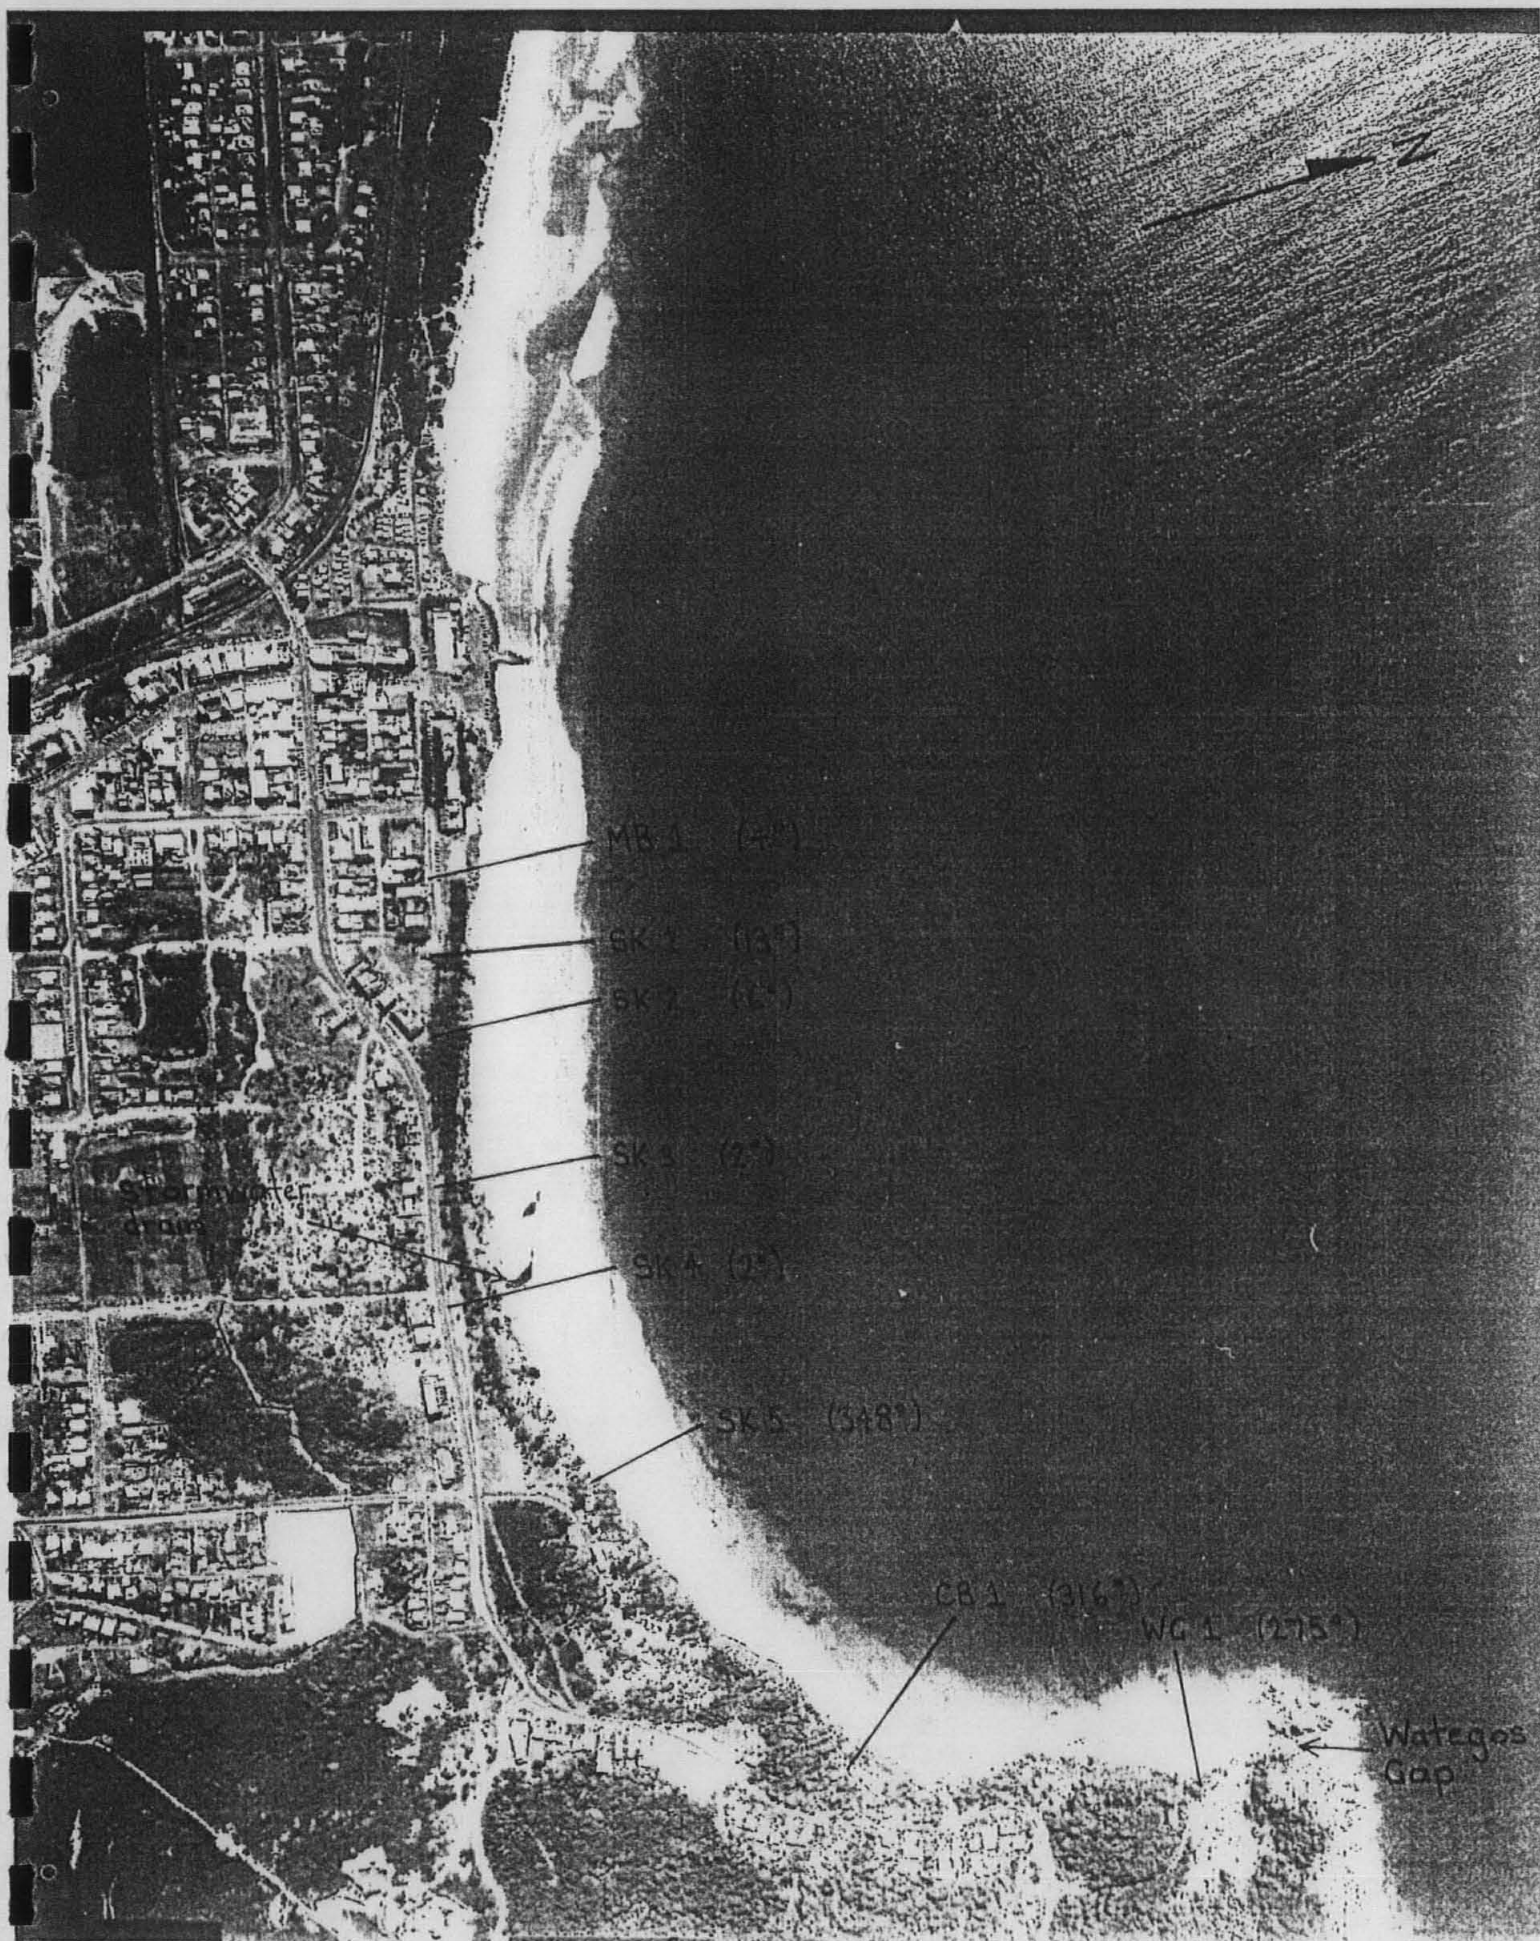
Figure 9 : Location of beach profiles.

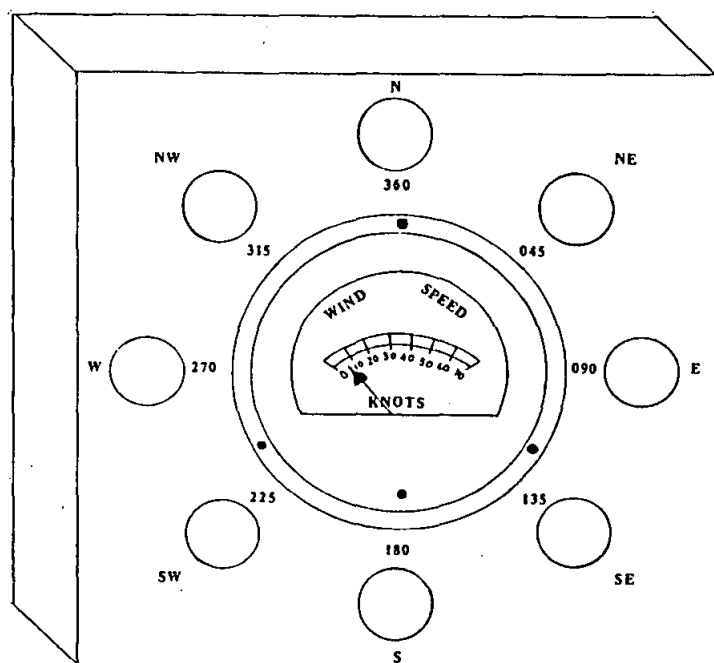
Figure 10: Diagram of Cape Byron wind direction/speed indicator.

A combination wind vane/cup anemometer located on the roof of the lighthouse keeper's cottage is electronically linked to a display unit in the cottage's 'weather room' (Fig. 10).

The wind vane measures wind direction which, as Figure 10 illustrates, is shown by the illuminated direction indicator lights on the display unit. At precisely three hourly intervals (except at midnight), the direction of the wind is read from the direction indicator to the nearest one of the 16 points of the compass. When two indicator lights are illuminated simultaneously (for example, north and north-east), the intermediate direction of the two lights is reported (north-northeast in this case). If two or more lights are flashing on and off, the intermediate direction of the two extreme flashing lights observed over a period of one minute is reported. If a power failure occurs, the wind direction is read manually from the wind vane.

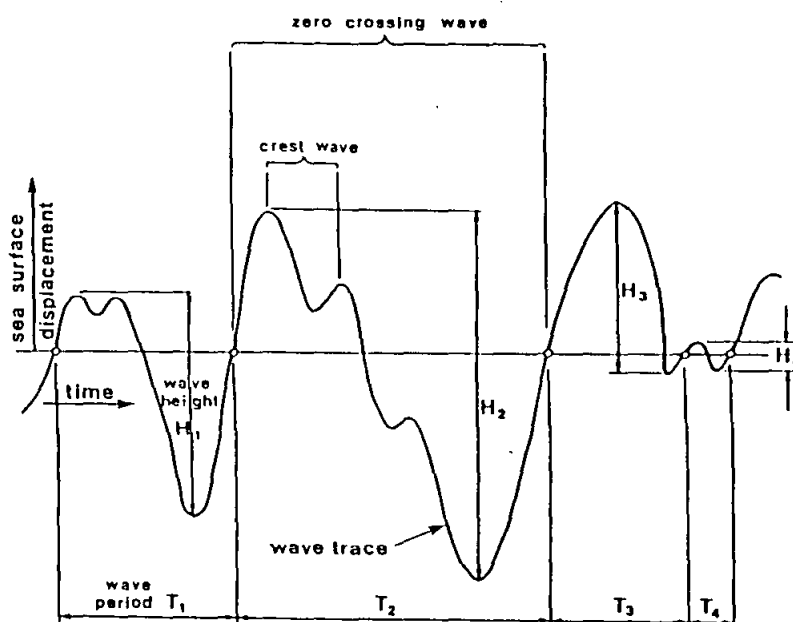
Figure 13: Zero crossing wave analysis.

A basic explanation of the method is provided in Figure 13.

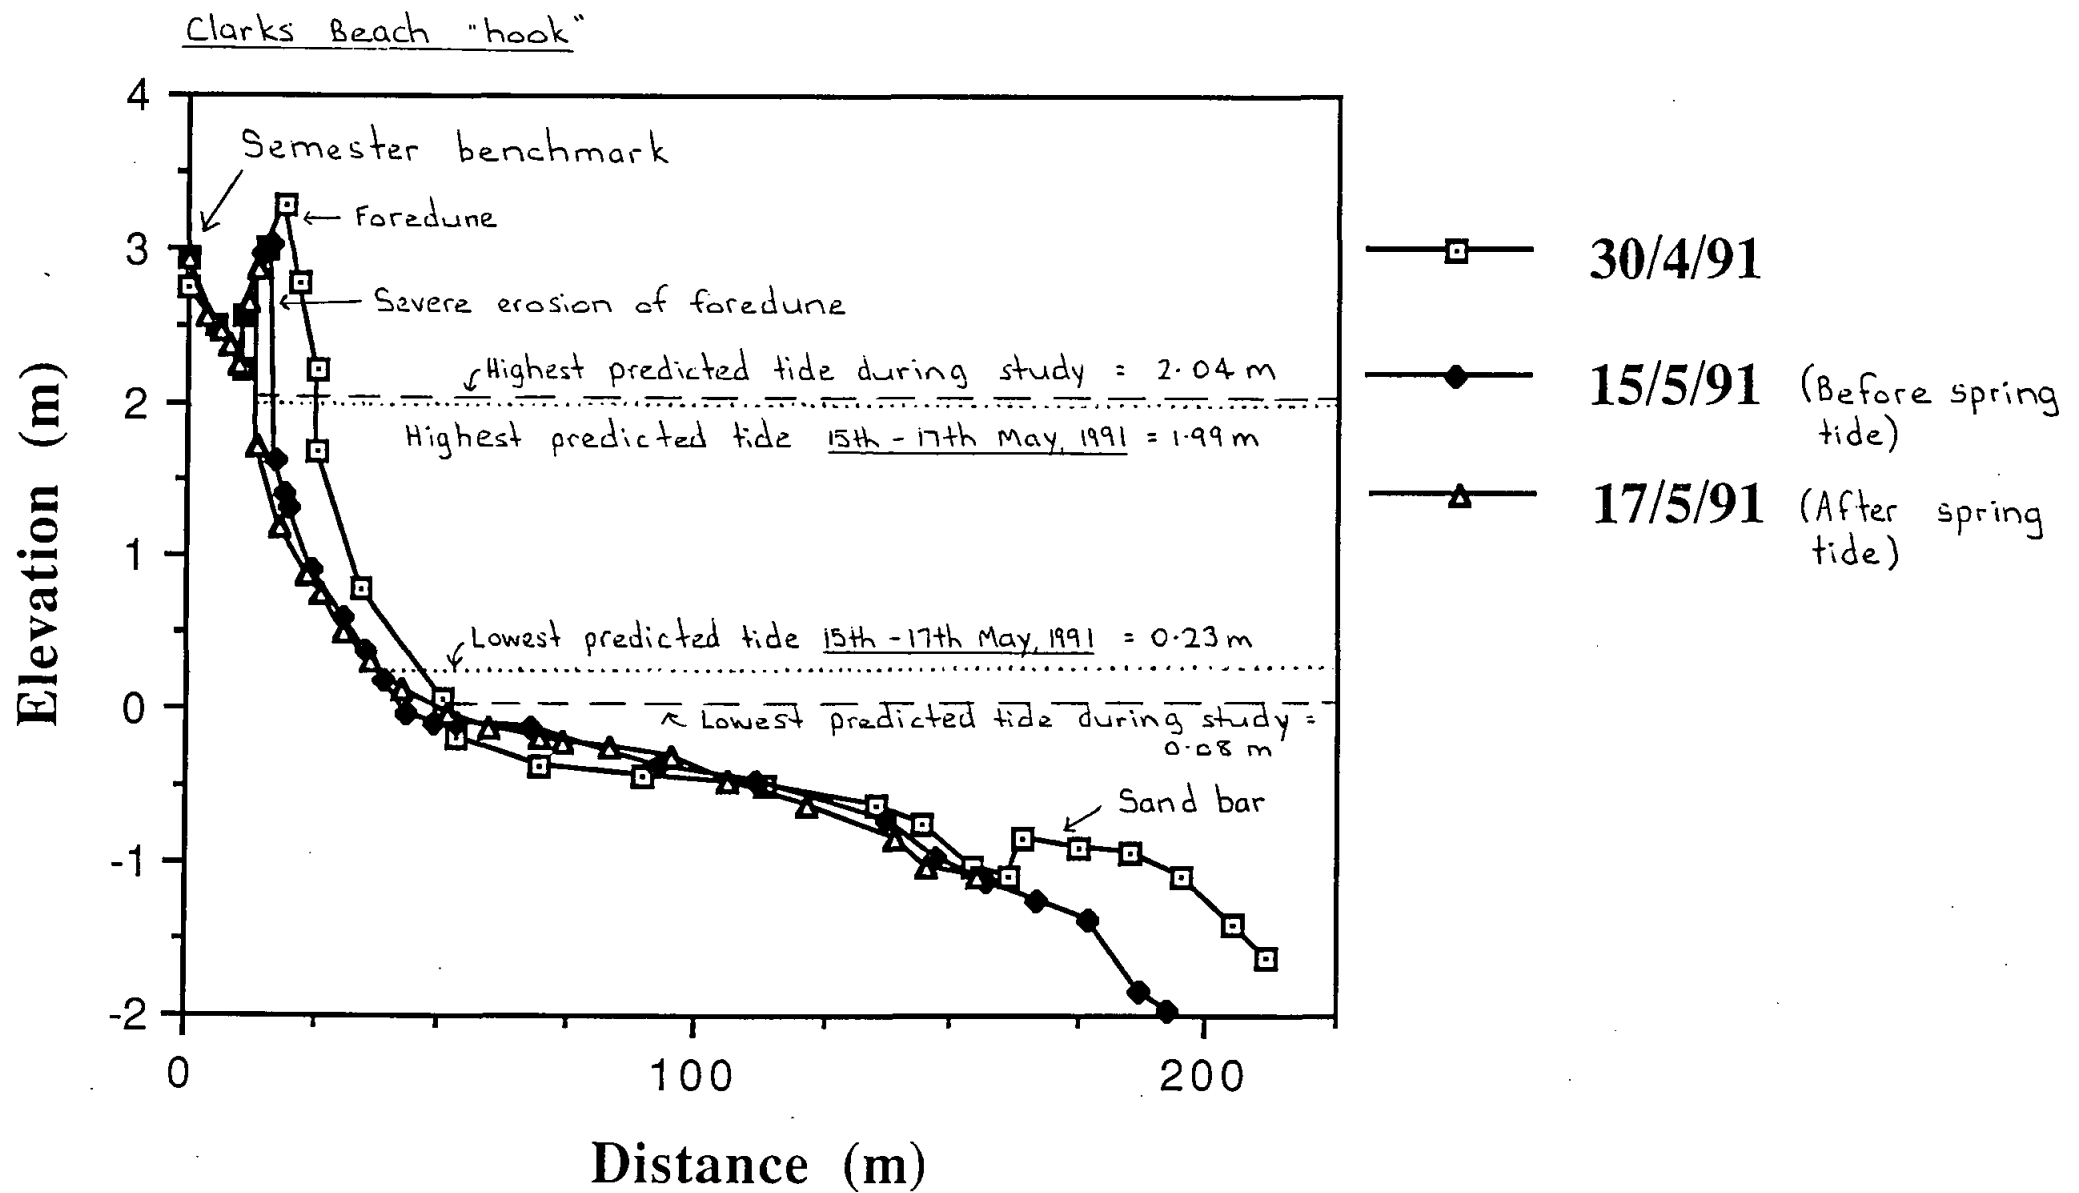
Figure 16: CB 1 - effect of extreme high tide event (1.99 m).

The most dramatic erosion occurred at profile line CB 1, where two 1.99 metre spring tides over the 15th - 16th May 1991 (Appendix E) caused the scarp to recede three metres in just two days.

The important result shown by this experiment is that even small waves can cause significant erosion during high tides. In the hook of Clarks Beach, on a spring high tide, short period waves can break right at the base of the erosion scarp causing it to be undermined and recede.

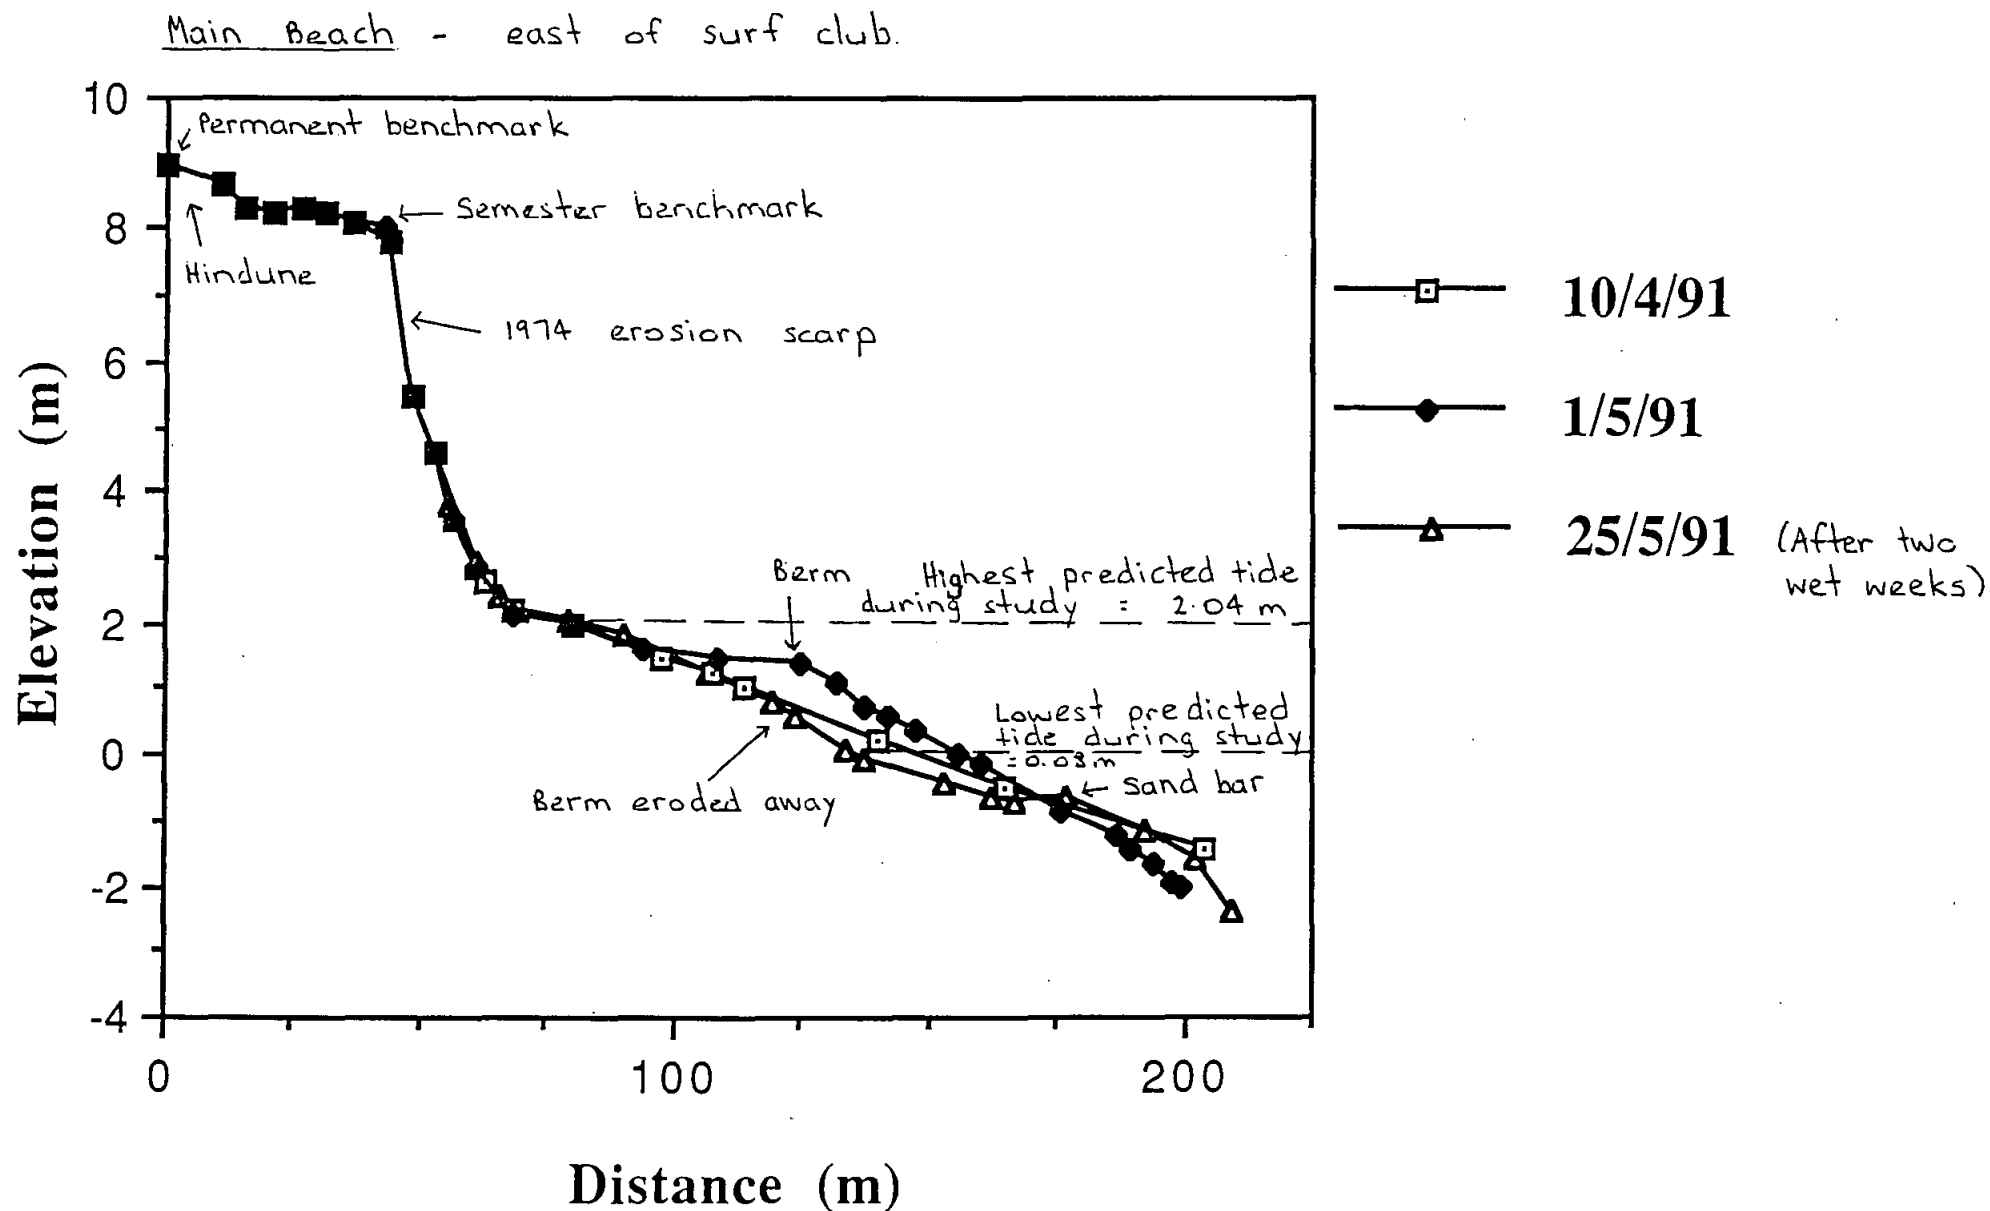
Figure 22: MB 1 profile changes.

By the 25th May, the entire beach berm at profile line MB 1 (Figure 22) had been eroded away. Storm waves moved a moderate quantity of sand from the beach and transported it offshore to form a small storm bar. The following meteorological and wave conditions were being experienced at the time:

A large, very slow moving high pressure system centred off Victoria and a low pressure system situated in the North Coral Sea directed a strong, moist, south-east to easterly air flow onto the coast. The results show that a short to average period swell of moderate height from the east was combined with locally moderate to rough seas. Two 1.99 metre spring tides were experienced over the 15th - 16th May. These factors all combined to cause the erosion at MB 1.

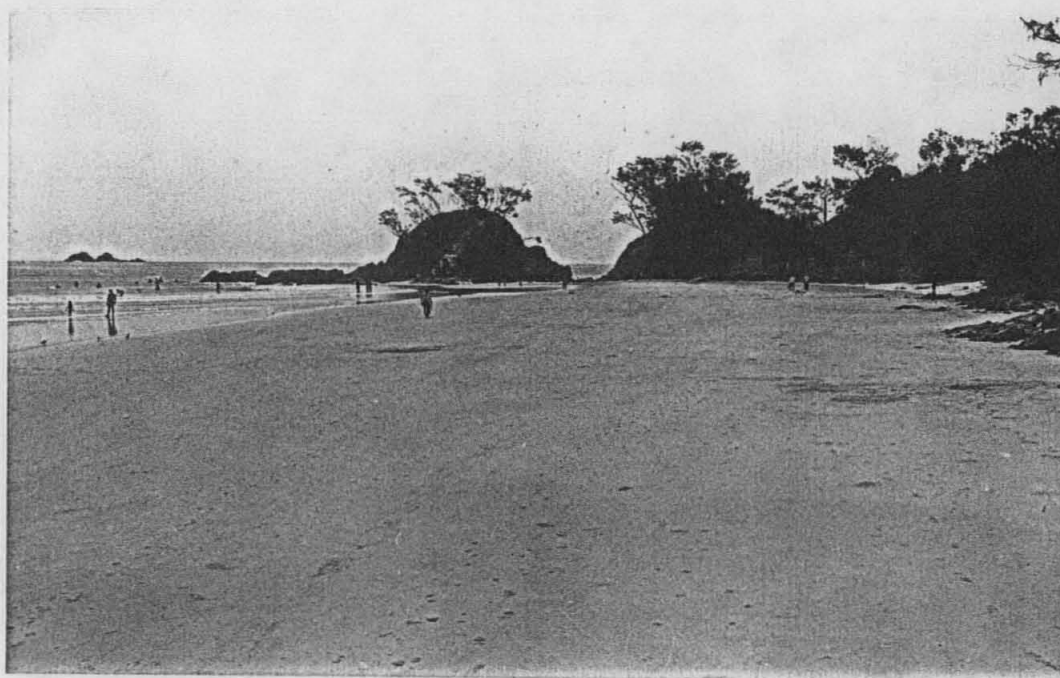
Figure 24: Sand build-up at the Pass, Byron Bay (20/4/91).

The significant deposition at the Pass over the period of the study (Fig. 24) may be a reflection of three processes; including an abundance of sand eroded from Wategos, sand transported from offshore, and an unusual sand corridor at Wategos Gap. It is possible that what sand is available off Wategos is not being transported shoreward (for reasons discussed in subsection 5.2.3), but rather is moving directly to the Pass area. Highly refracted fair-weather waves would allow an abundance of sediment to accumulate in the protected area behind the rocks here.

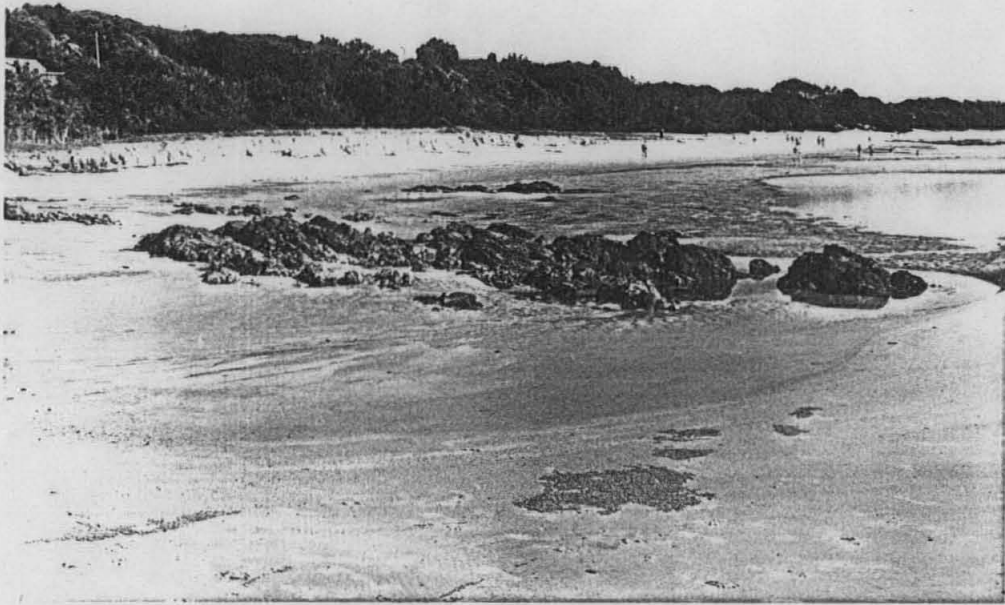
Figure 25: Erosion in the "hook" of Clarks Beach, Byron Bay (1/5/91).

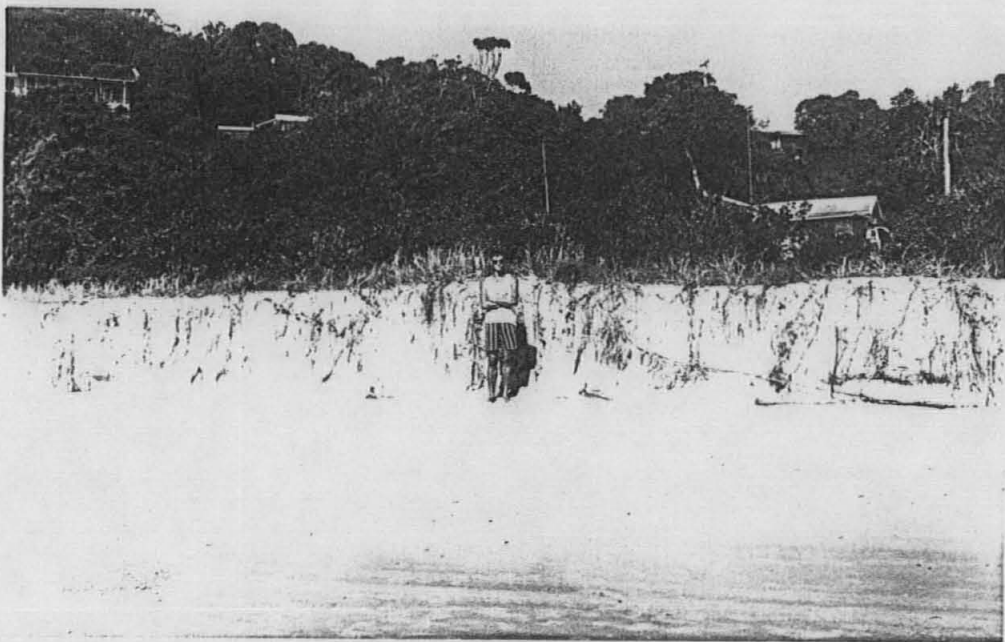
Figure 26: Clarks Beach erosion scarp (1/5/91).

The waves in the hook of Clarks Beach are too refracted to push sand shoreward, but are just the right size to pass over the shallow bottom at high tides to expend their energy on the visible beach and erode it (Figure 25 and 26). This is discussed more fully in subsection 5.3.1.

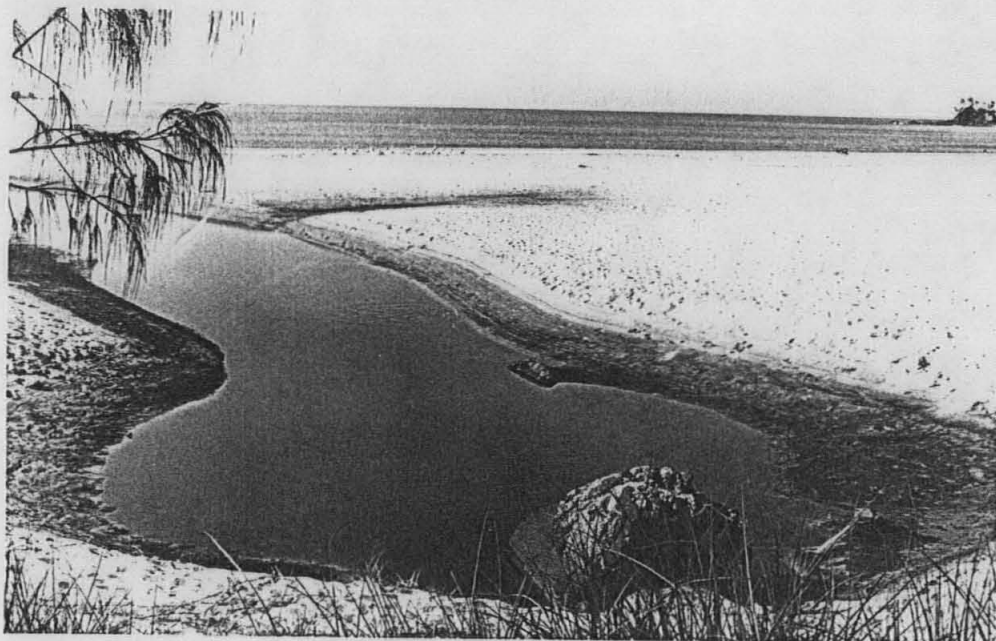
Figure 27: Stormwater drain on Clarks Beach, Byron Bay (19/4/91).

The beach skimming has failed in one respect, in that no control over the stormwater drain has been achieved. This continues to be a problem and is considered an "eyesore" by locals and tourists alike. Furthermore, the extra sand trapped near the dune by bulldozing is no longer available to the longshore drift and may eventually cause erosion further west.

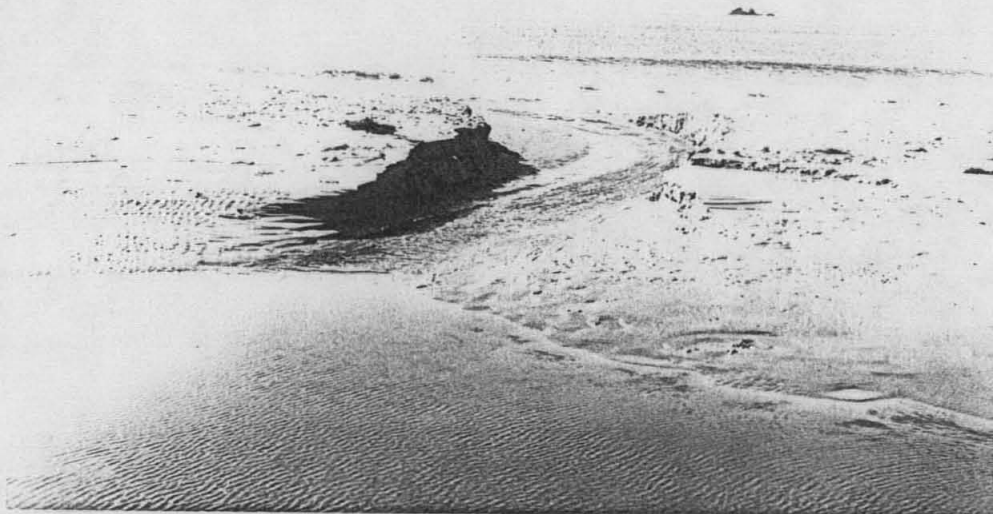
Figure 28: Severe scouring by Clarks Beach stormwater drain (19/4/91).

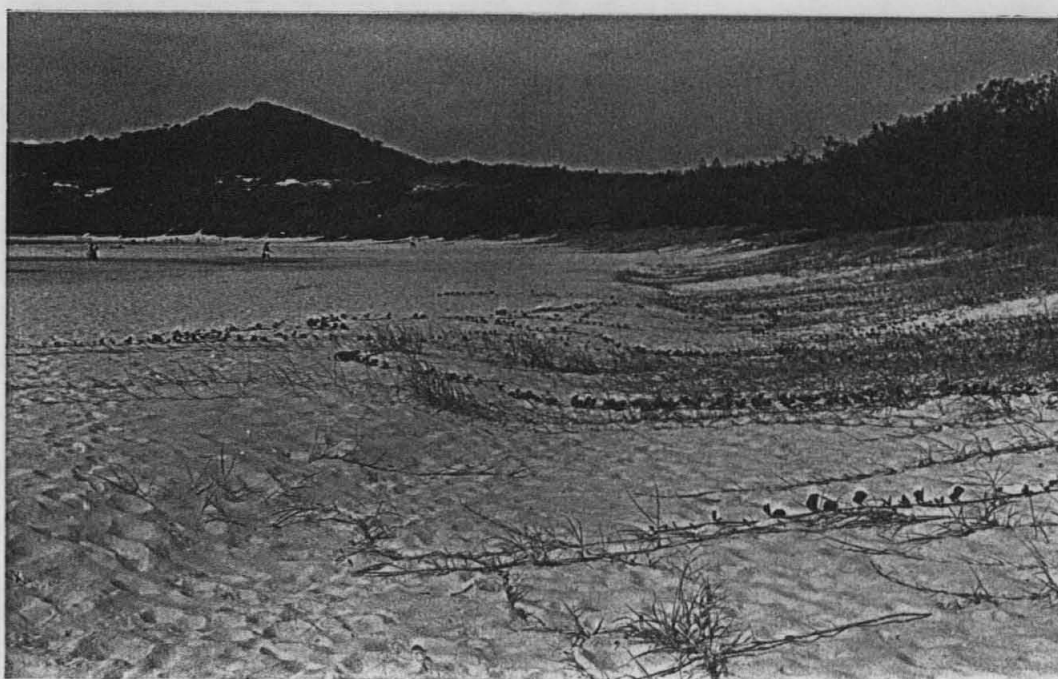
Figure 29: Sand reservoir along Main Beach, Byron Bay - created by beach skimming operation. Photograph taken 19/4/91.
