Wyong Shire Council

Review of Environmental Factors Maintenance Dredging at the Mouth of Tumbi Creek, Killarney Vale

April 2002

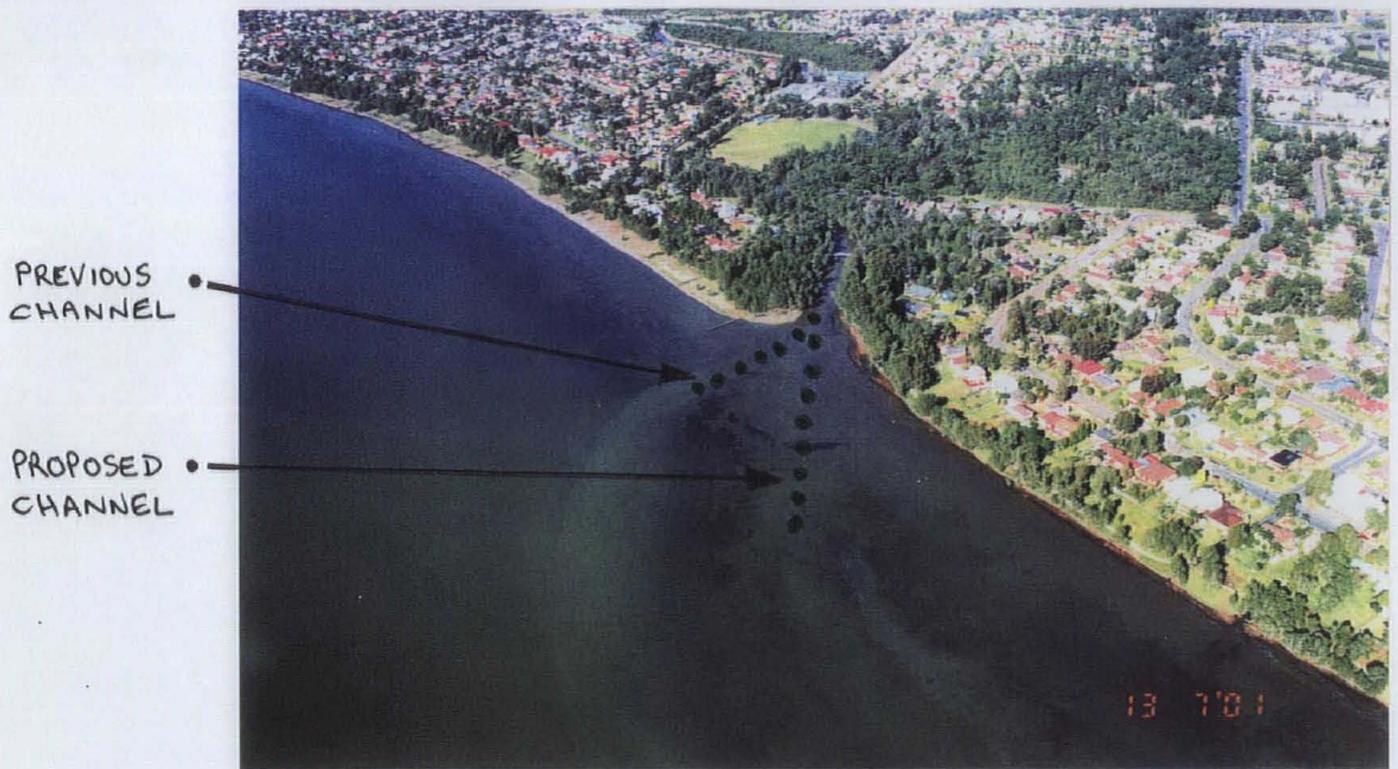
Above: Aerial photograph showing mouth of Tumbi Creek, previous channel and proposed channel

Council's proposal will involve cutting a new channel to the west of the old channel, with the channel facing a more northerly direction than the north-easterly orientation of the old channel. This is considered to be closer to the position of the original creek and should assist in maintaining the channel in an operational condition. The new channel will also have a larger volume, which is expected to provide a longer operational life.

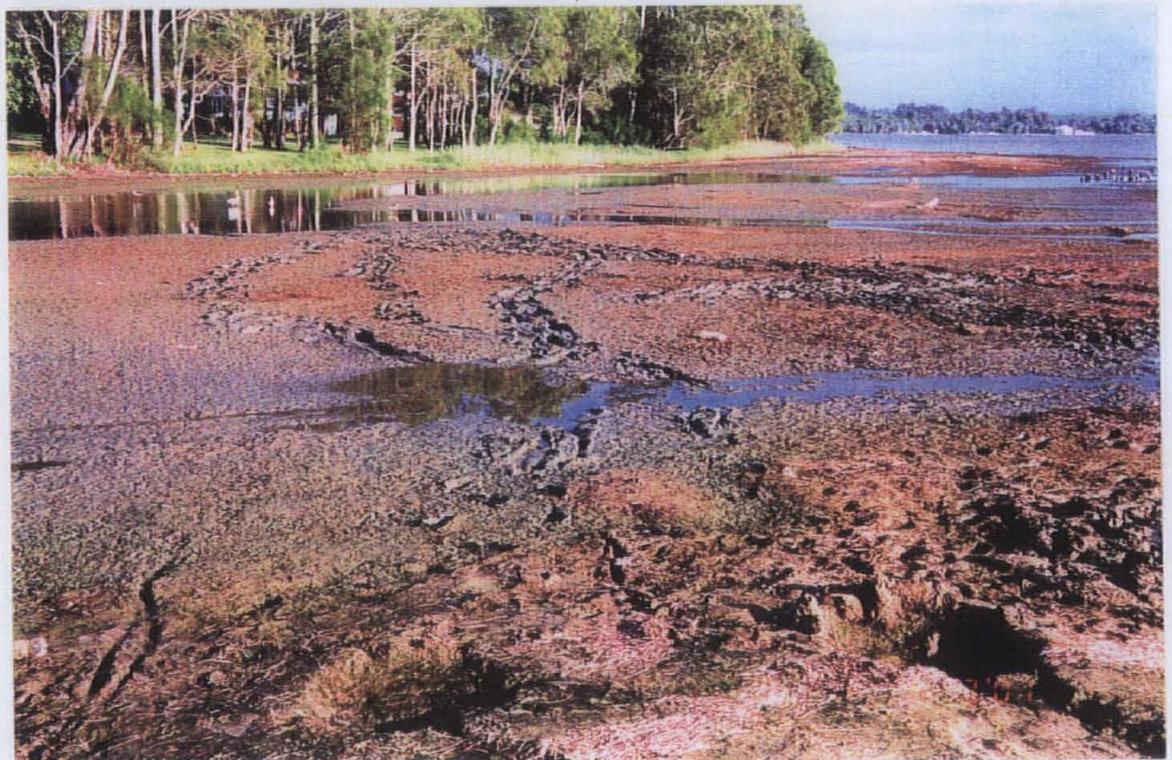
Below: Extent of Siltation at mouth of Tumbi Creek

Soundings and surveys carried out by Council have confirmed that the existing navigation channel at the mouth of Tumbi Creek has accreted to the point where it is no longer passable by any watercraft. When Tuggerah Lake is at a level of 0.0 m to 0.1 m Australian Height Datum (AHD) there is practically no interchange of water between the Lake and Tumbi Creek. There is a land bridge above water level across the mouth of the creek at these average lake levels. The extent of this siltation is obvious from the photographs in the Appendices.

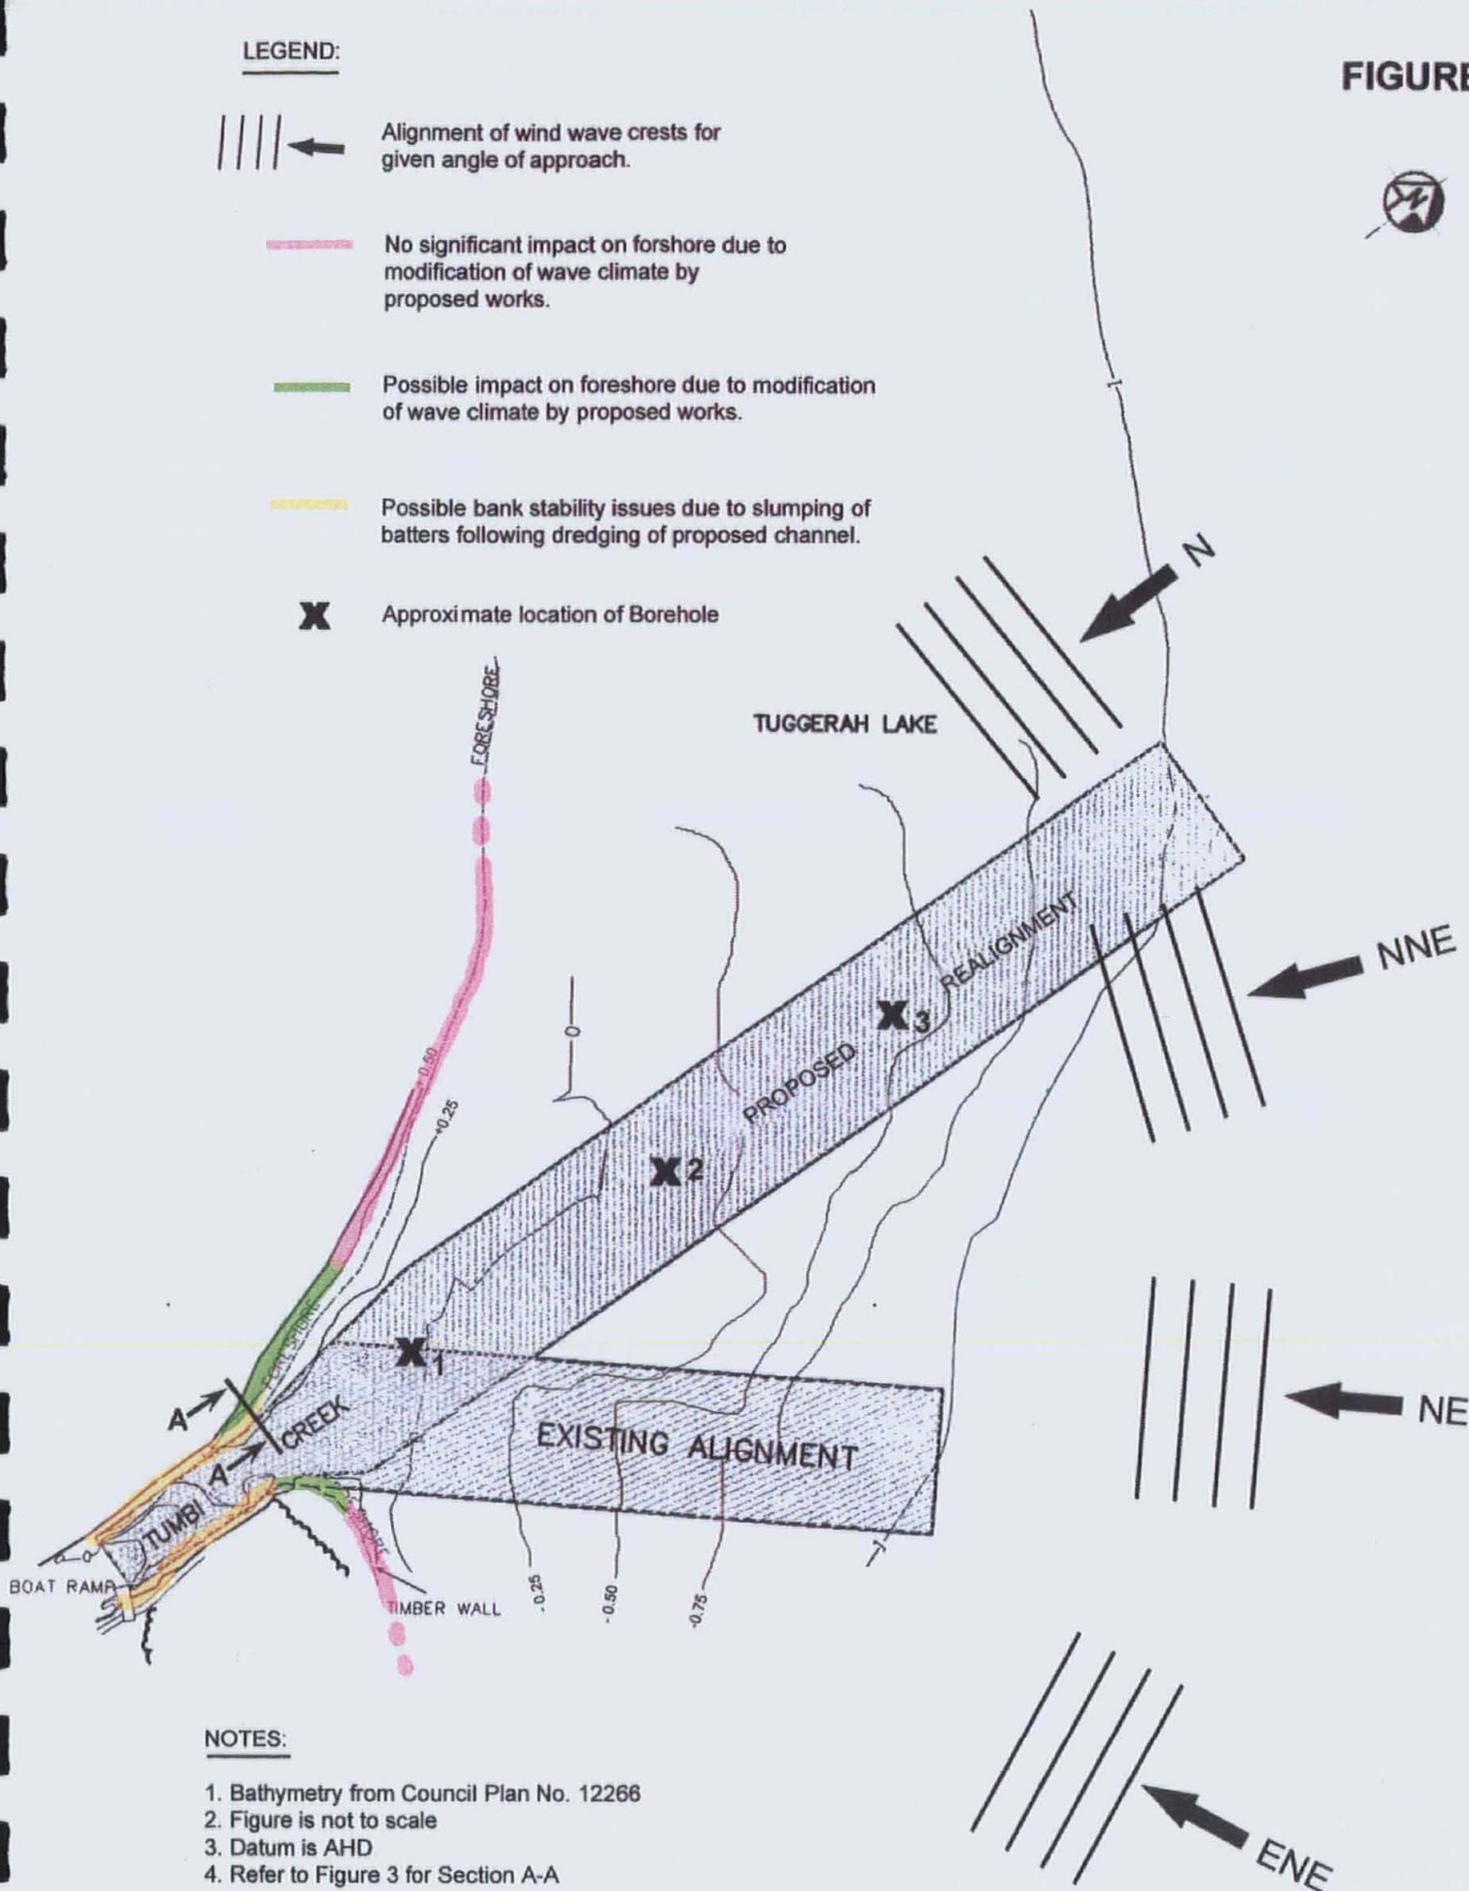
Possible bank stability issues due to slumping of batters following dredging of proposed channel.
- X** Approximate location of Borehole

1. Bathymetry from Council Plan No. 12266
2. Figure is not to scale
3. Datum is AHD
4. Refer to Figure 3 for Section A-A

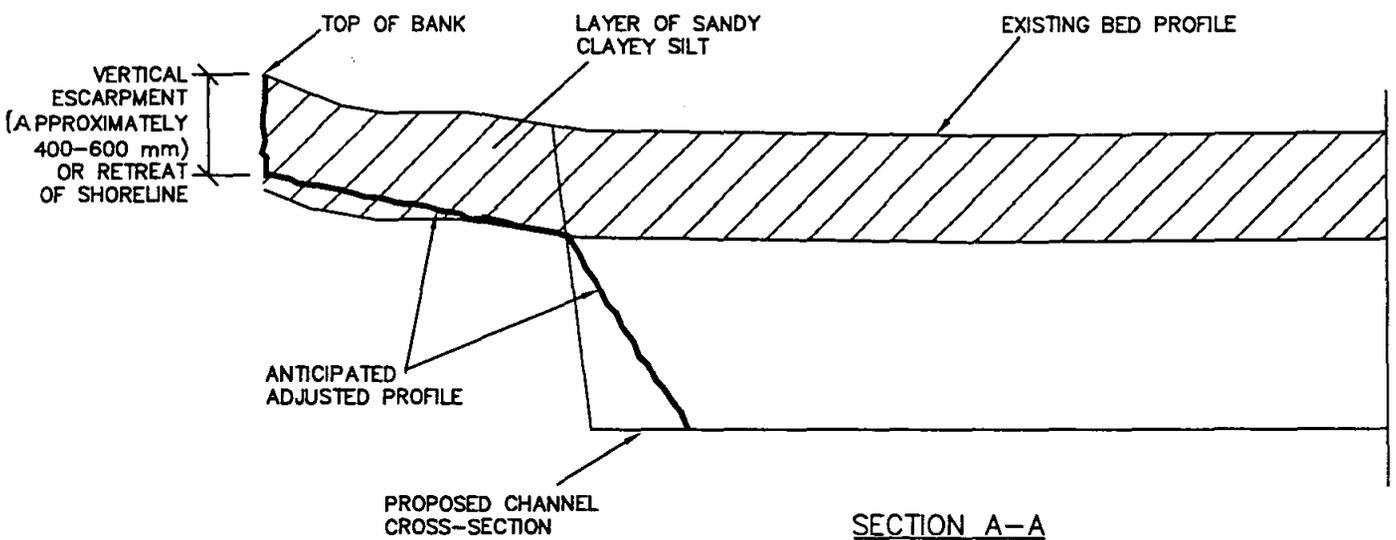
FIGURE 3

- NOTES:
1. REFER TO FIGURE 1 FOR LOCATION OF SECTION A-A.
 2. FIGURE NOT TO SCALE (2x VERTICAL EXAGGERATION).

**CROSS-SECTION SHOWING ANTICIPATED
ADJUSTMENT OF BATTERS FOLLOWING
DREDGING OF PROPOSED CHANNEL**
