This booklet contains a summary of the findings of the Byron Bay—Hastings Point Erosion Study. The study represents two years work by a multidisciplinary team of coastal experts and has succeeded in identifying and quantifying the causes of coastal erosion in the Byron Bay—Hastings Point region.

#### **FOREWORD**

The Byron Bay Hastings Point Erosion Study was set up with the prime objective of gaining an understanding of the coastal processes governing erosion in the region. The full results of this investigation are presented in Department of Public Works, Coastal Engineering Branch Report No. PWD 78026, November 1978, which is available from offices of the Public Works Department.

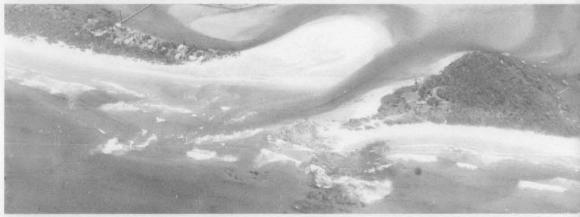
#### BRUNSWICK RIVER ENTRANCE, 1955.

Prior to construction of the breakwaters, the exposed rock reef at the entrance was already causing realignment of the beach in the Sheltering Palms region.

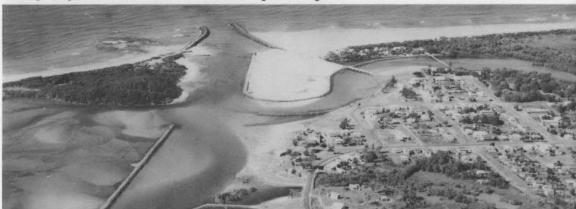
#### BRUNSWICK RIVER ENTRANCE, 1962.

On completion of the breakwaters, sand bypassing of the entrance across the entrance bar commenced immediately. The realignment of the beach to the south is complete.

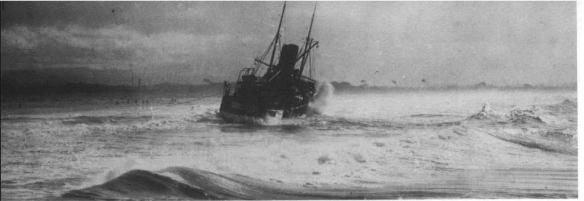
THE WRECK OF THE WOLLONGBAR, BYRON BAY, 1921.

The "Wollongbar", the pride of the North Coast Steam Navigation Company, carried on trade between Byron Bay and Sydney on a weekly basis. She was driven up on the beach during a storm in 1921, and the wreckage may still be seen in front of the swimming pool at low tide.

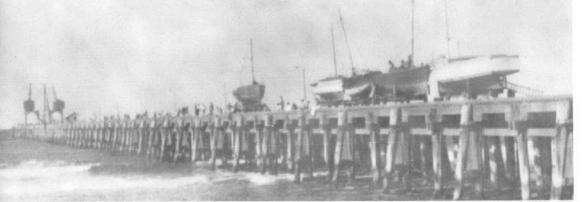
#### THE SECOND JETTY AT BYRON BAY, CONSTRUCTED IN 1928.

The original Byron Bay Jetty constructed in 1888 became unsafe and was replaced by the new jetty in 1928. The fishing fleet which worked from Byron was lifted onto the jetty by cranes for protection during severe storms. On occasions damage to fishing boats did still occur.

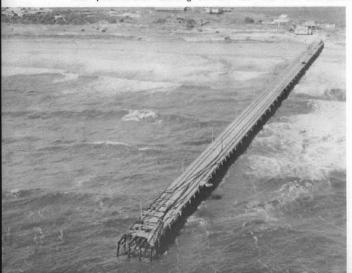
### DAMAGE TO JETTY AT BYRON BAY, 1954.

Byron Bay's days as a trading port came to an end when the jetty was destroyed during storms in February 1954. Twentysix fishing boats were destroyed and the Fishermen's Co-op moved to Brunswick Heads. Subsequently the jetty was shortened and used in conjunction with the whaling station. When whaling operations ceased in 1962 the jetty fell into a state of disrepair and was eventually removed in 1972.

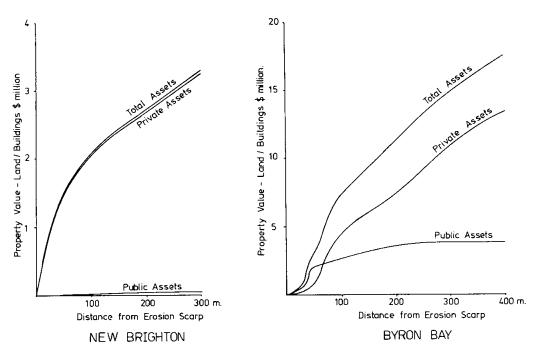
PROPERTY VALUES AS A FUNCTION OF DISTANCE FROM 1977 EROSION SCARP

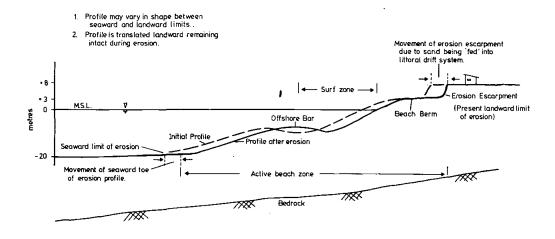
INTACT EROSION PROFILE CONCEPT

The term 'beach erosion' is itself misleading. During storm events, sand located on the beach berm moves offshore to form bars and, subsequently, moves back onshore during favourable weather conditions. Research in this region typically extends from approximately 3 metres above mean sea level (the top of the berm) to 20 or 30 metres below mean sea level. Within these limits, erosion and accretion of the beach berm (usually termed the beach) is associated with the opposite trend in the nearshore region.

However when a nett loss of sand occurs from this dynamic beach system, the existing profile is moved inland, the quantity of sand lost being re-established by erosion of the backshore deposits where they exist.

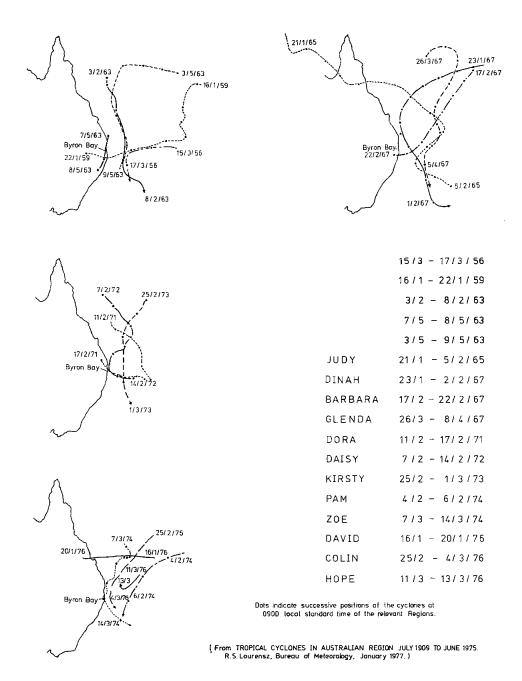
PATHS OF TROPICAL CYCLONES AFFECTING
THE BYRON BAY TO HASTINGS POINT EMBAYMENT 1956 — 1978

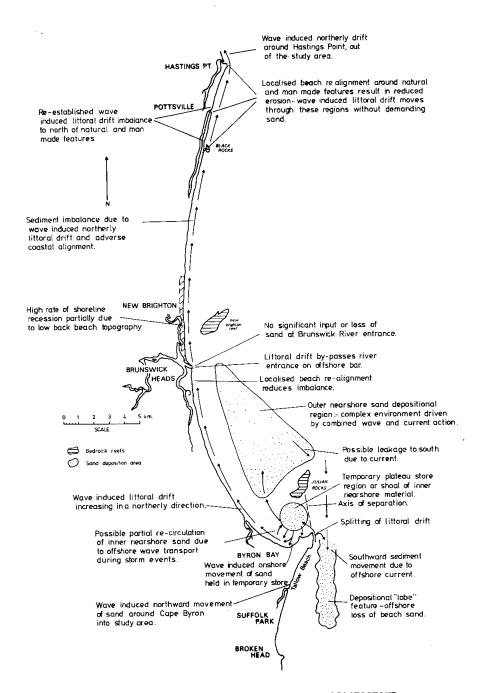
CONCEPTUAL MODEL OF SEDIMENT MOVEMENT

The predominantly south easterly wave conditions incident to this region of the coast cause a northerly sand movement along Tallow Beach.

At the northern end of this beach some 65,000 cubic metres per year of sand is transported by the littoral drift system into the shallow region off Cape Byron. At the tip of the Cape this sand stream experiences interference from an offshore current. This current is variable in both strength and location but tends to flow predominantly from north to south. Although no firm evidence has been found as to its origin, it is believed to be associated with the East Australia Current; a strong deepwater current which flows north to south down the N.S.W. coast off the continental shelf. Measurements taken immediately off Cape Byron recorded velocities of up to 1 knot, however reports from local fishermen indicate that at times it can be well in excess of this value.

The sand which successfully negotiates Cape Byron under wave driven currents enters the Byron Bay—Hastings Point system and is deposited in a region between Wategos Beach and Julian Rocks. From here it is moved onto Wategos Beach in 'slugs' depending on the prevailing weather conditions. It then flows from here around and through "the pass" onto Clarks Beach where it initially appears as a sand spit which grows until a lagoon is created between it and the existing beach. This lagoon slowly fills in as more sand is added and at this stage Wategos Beach is left with little sand and hence appears to be in an eroded state.

In the hook of Byron Bay — Clarks Beach, the littoral drift is predominantly northward around the shoreline. With increasing exposure to the south easterly and easterly waves, littoral drift rates increase, resulting in a littoral drift differential along the beach. This drift differential creates a demand for sand which is satisfied by erosion of the foreshore.

In addition to the erosion caused by the need for the littoral drift system to regain the sand lost off the Cape to the offshore current, the change in coastal alignment throughout the Byron Bay—Hastings Point embayment acts to increase the drift rates throughout the compartment.

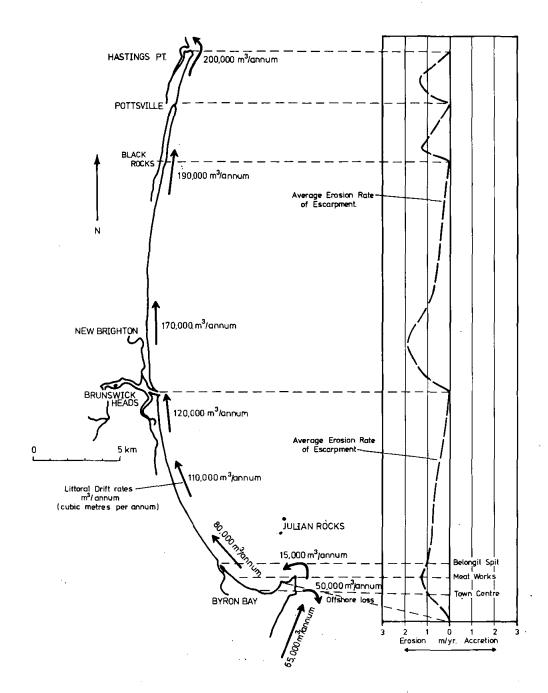
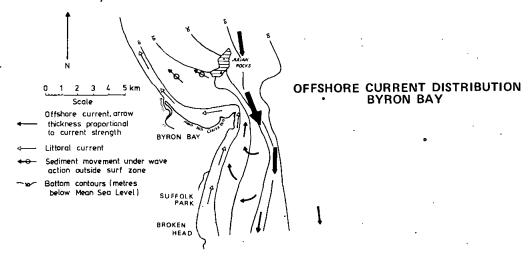
QUANTIFICATION OF EROSION RATES

At Hastings Point some 200,000 cubic metres per annum moves to the north out of the compartment which means that on average 185,000 cubic metres per annum of sand is removed from the coastal plain deposits of the Byron Bay — Hastings Point region.

Hence, the sediment imbalance which causes erosion of the foreshore in the Byron Bay — Hastings Point compartment is due to both an offshore loss of material which would otherwise enter the compartment from the south around Cape Byron and to the unfavourable coastal alignment which increases the littoral drift systems demand for sand.

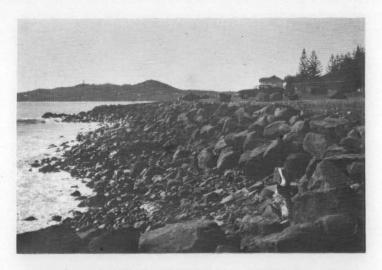
ROCK REVETMENT, BYRON BAY, SEPTEMBER 1977

A rock revetment placed to halt beach erosion will result in loss of the beach amenity. Continued steepening of the offshore slope will result in increasing maintenance costs for a revetment and eventually the coast will consist of a rubble shoreline. Unless a revetment is continuous throughout the region undergoing erosion, increased erosion on the downdrift side may cause outflanking and failure of the structure.

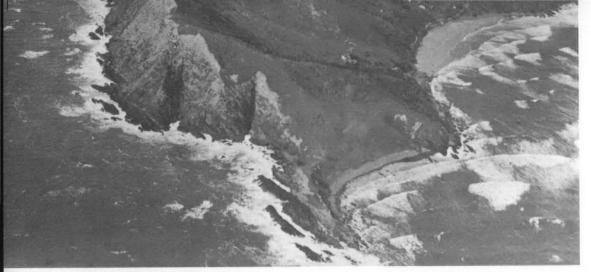
#### CAPE BYRON, 1954.

Sand moves around Cape Byron under southerly wave action in the form of a slug. Initially the sand appears on Little Wategos Beach immediately to the west of the tip of the Cape. From here it is transported, under wave action, to Wategos Beach. In this photograph Little Wategos Beach (right hand foreground) is depleted of sand while Wategos Beach (right hand middle ground) is comparatively full.

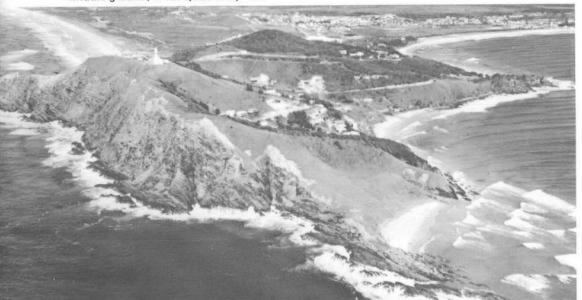
#### CAPE BYRON, 1973.

This photograph shows the reverse situation to that pictured above. Little Wategos Beach is full of sand while Wategos Beach is depleted. Observation showed that a slug of sand moving around the Cape will move from Little Wategos Beach to Wategos Beach then via the Pass onto Clarks Beach and hence into the littoral system of the Byron Bay-Hastings Point embayment.

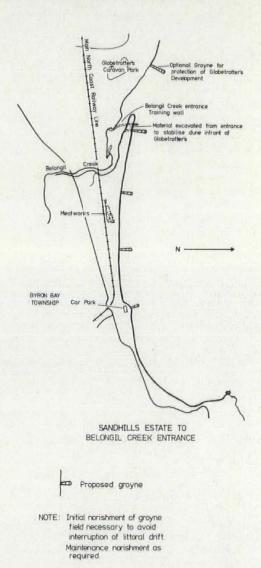
**GROYNE OPTIONS**

Groynes may trap sand on their updrift side but cause accelerated erosion on their downdrift side. Initial nourishment is necessary, and a small terminal revetment may also be required to limit the landward fluctuation of the beach. A series of groynes will change the alignment of the beach to a scalloped appearance. Small pocket beaches form between each of the constructed groynes.
