Records of the Geological Survey of New South Wales

**COASTAL GEOLOGY OF THE CUDGEN AREA,
NORTH COAST OF NEW SOUTH WALES**

By P. S. ROY

1975

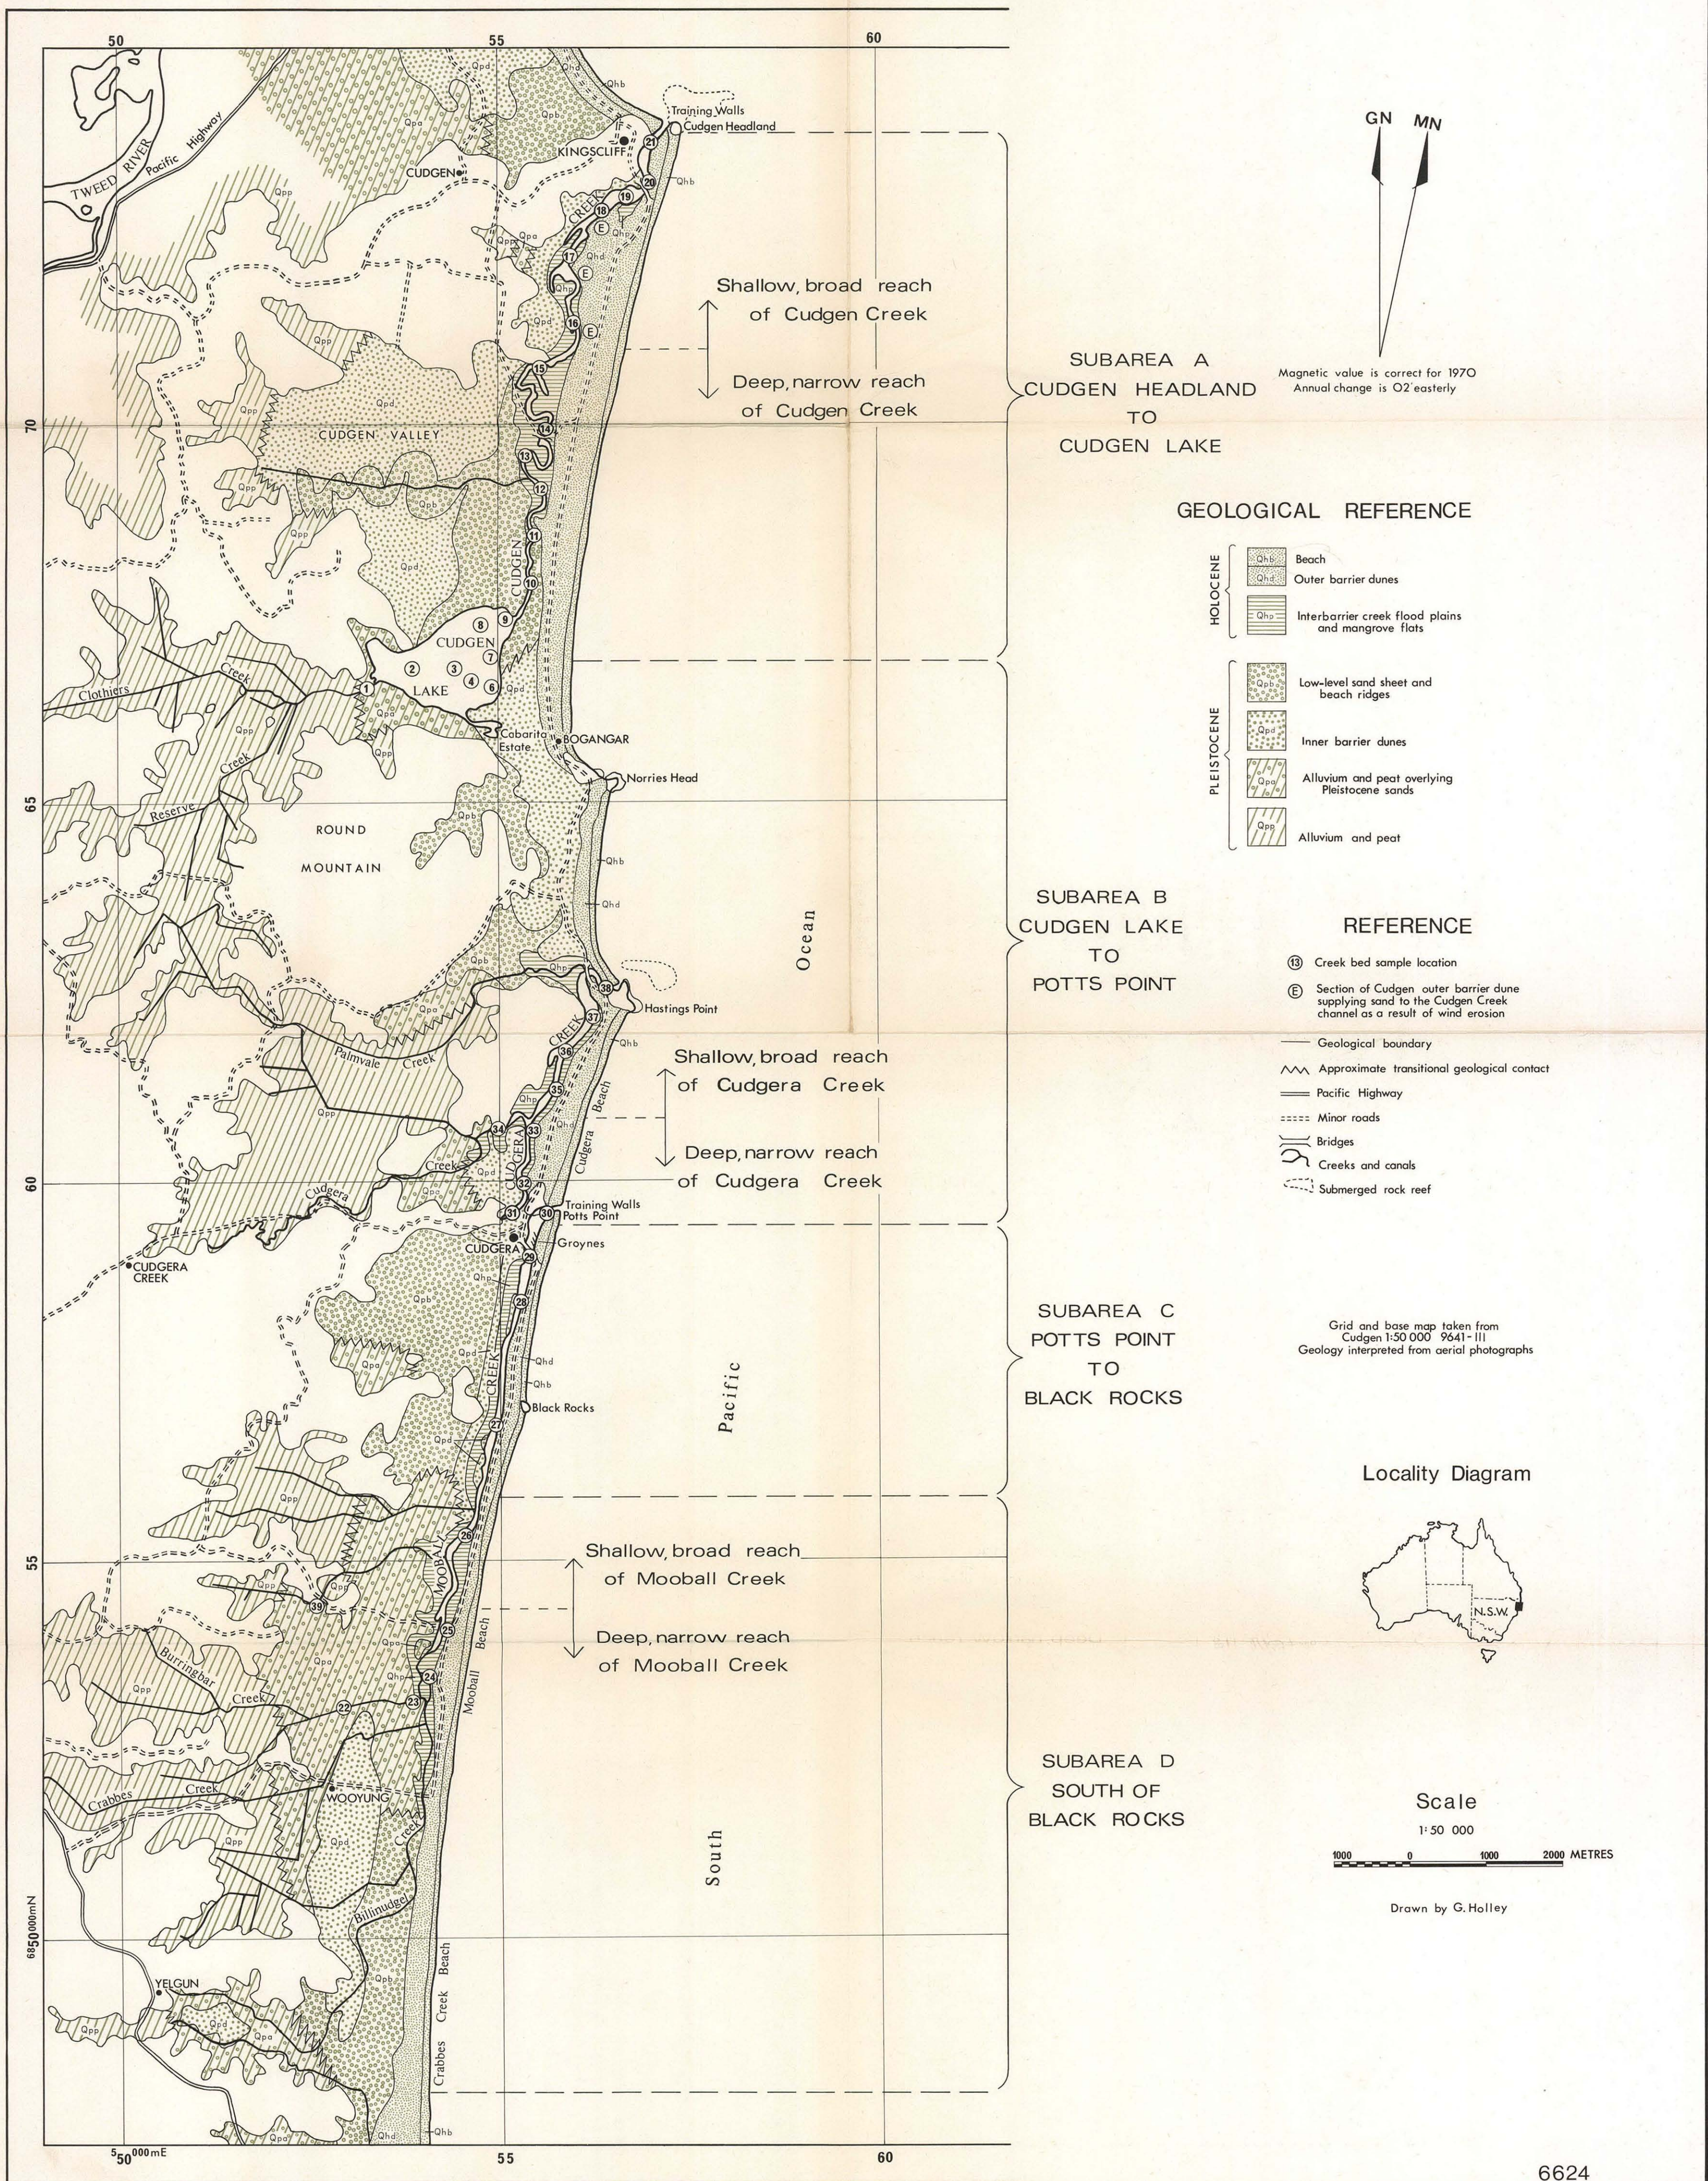
COASTAL GEOLOGY OF THE CUDGEN AREA

flooding regime of the area, or is due mainly to a real physical deterioration of the drainage systems through man-induced changes. Very probably both factors are involved. In assessing the geological situation, observations were made of the processes operating in the creeks under present day conditions and inferences were drawn as to the likely effects over a period of time of some of the developmental activities. The distribution of unconsolidated sediments in the study area is shown on figure 1.

For descriptive purposes the coast has been divided into four subareas as shown on figure 1.

Thirty-nine dredge samples were collected in the beds of the creeks and in Cudgen Lake at locations shown on figure 1. The mud/sand ratio was measured and the washed-sand fraction examined microscopically.

The interbarrier creeks in the study area are divisible into two reaches: a narrow and relatively deep upstream reach and a broad and shallow downstream reach (see figure 1).
